Tree Inventory and Construction Impacts to Trees at 256 and 292 Gibraltar Drive

Prepared by  
Don Thomas, Medallion Landscape  
Certified Arborist WE-1507  
January 4, 2005

**MEDALLION LANDSCAPE ATTACHMENT G**  
**MANAGEMENT, INC.** Page 13 of 20**Report on Sidewalk Construction Impacts on Canary Island Pines  
At 256 and 292 Gibraltar Drive  
Prepared by  
Don Thomas, Certified Arborist**

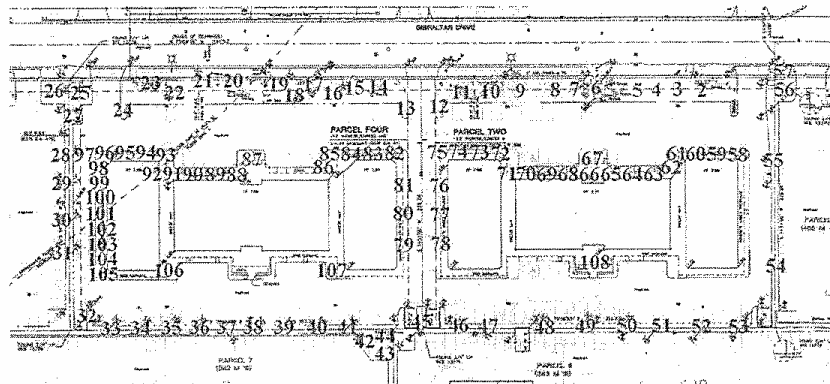
Figure 2. Trees at 256 and 292 Gibraltar Drive, identified by tree number. (See Table 1.)

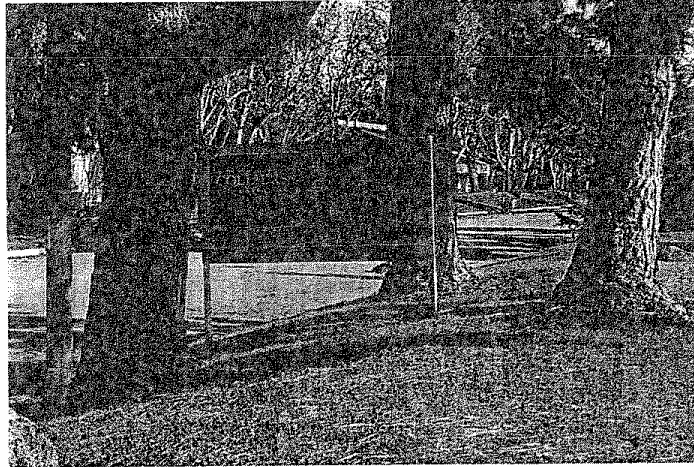
Photograph 1 shows the trees designated as trees 1, 2 and 3 on the site map. It was found that one of the pines, tree 1, has one large root within 5 feet of the curb. This root is shown in Photograph 2. Severing of this root might cause stress to the tree because of reduced water and nutrient uptake.

Photograph 1. Canary Island pine trees 1, 2, 3 and 4 in front of 256 Gibraltar Drive.

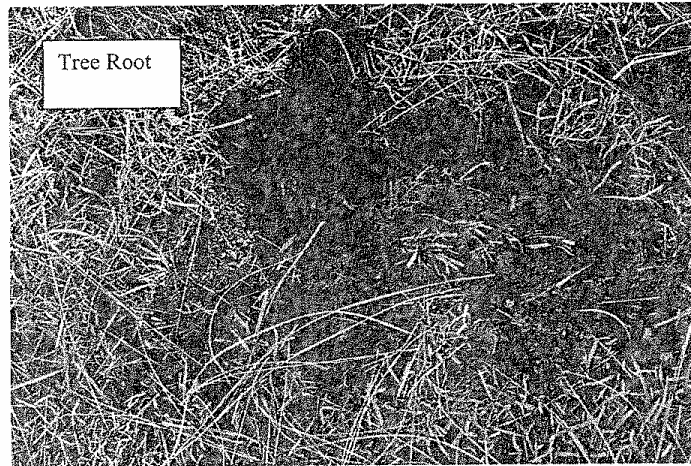
Photograph 2. Large root of tree 1 that would be impacted by sidewalk construction.

However, significant stress can be expected for a few of the pine trees if roots are cut, including trees 1, 3 and 5. Tree 3 should be considered for removal. The other trees should be evaluated for stress after construction. Tree 9 may tolerate cutting of the large root near the curb but should be evaluated for resulting stress. Consideration should be given to removal and replacement of tree 11 because of its poor root conformation.

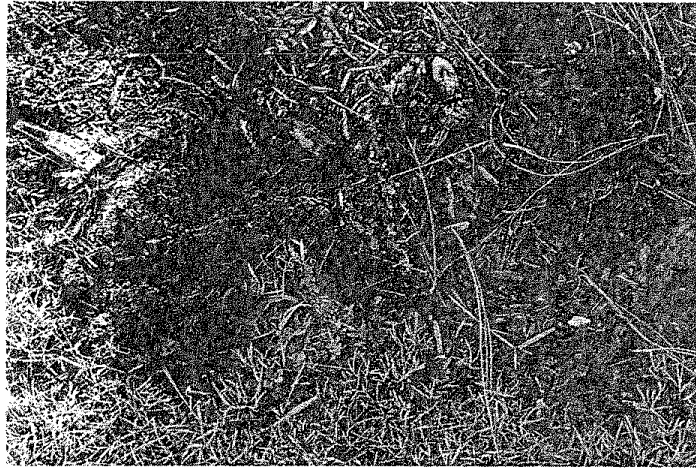
Tree 3 has a number of large roots within 5 feet of the curb (Photograph 3), and the trunk is only about 6 feet from the curb. This tree would experience significant stress if roots were cut for the sidewalk. Not only would the supply of moisture and nutrients be reduced, but the structural stability of the tree might be compromised because some of the main anchoring roots would be severed. This tree might need to be removed. In addition to the hazard posed by loss of root stability, it also has co-dominant leaders (a

double trunk), which increases its hazard potential because of the possibility that the two trunks might split apart in a storm.

Photograph 3. Large tree roots of tree 3.

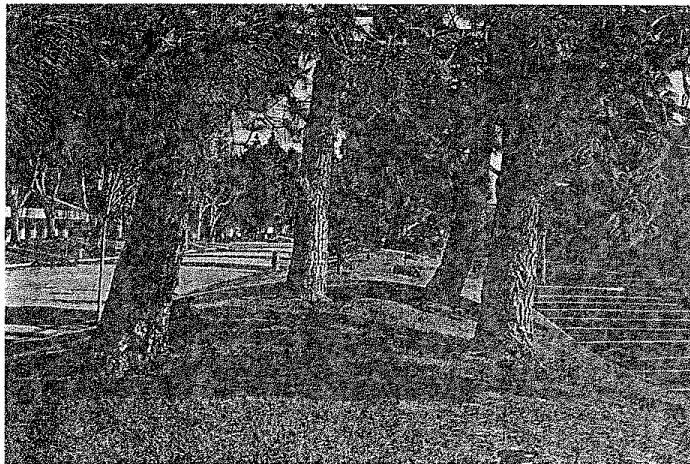
Photograph 4 shows trees 4, 5, 6 and 7. Tree 5 was found to have a major root about 4 inches in diameter within 5 feet of the curb (shown in Photograph 5). Cutting of this root will result in significant root system loss and can be expected to result in stress. The other trees in this group were found to have only small roots near the curb and would probably not experience much stress.

Photograph 4. Trees 4, 5, 6 and 7 in front of 256 Gibraltar Drive.

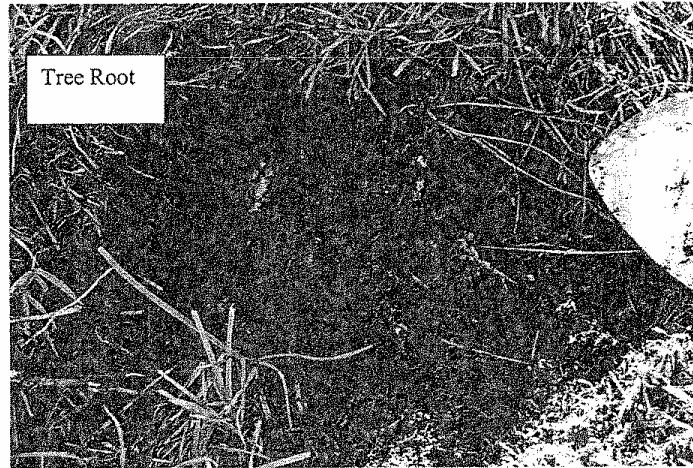
Photograph 5. Large root of tree 5 that would be impacted by sidewalk construction

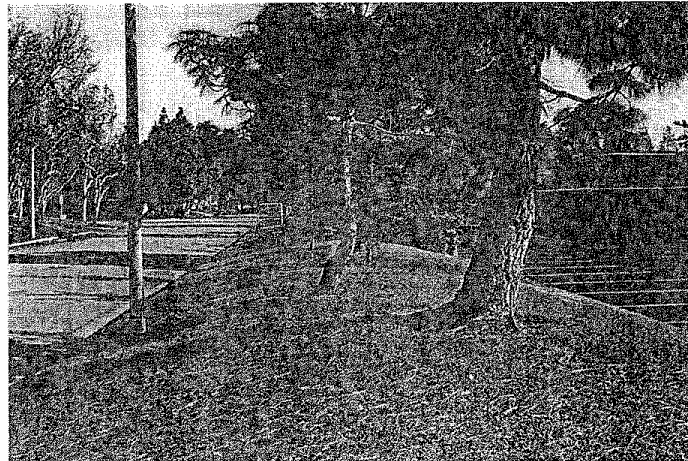
Photograph 6 shows trees 8 and 9 in front of 292 Gibraltar Drive. Tree 8 has a number of small roots within 5 feet of the curb but no large roots. Tree 9, though smaller than tree 8, has one root about 1 inch in diameter that would be cut if a sidewalk were constructed. The root zone near tree 9 has already been somewhat impacted by the presence of the nearby street light.

Photograph 6. Trees 8 and 9 in front of 292 Gibraltar Drive.

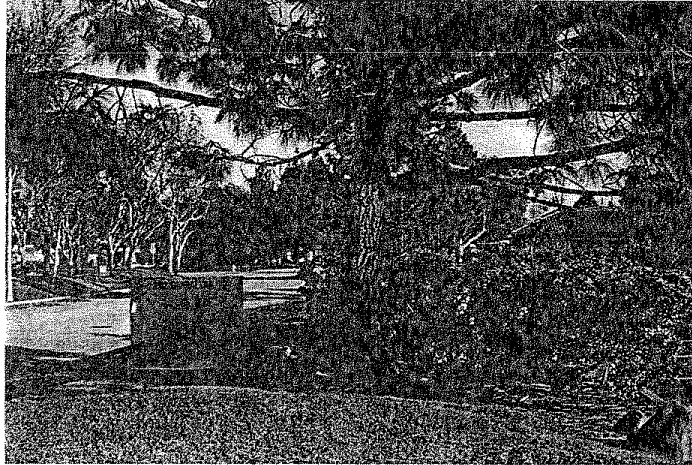
Photograph 7 shows tree 10, which is near the sign for 292 Gibraltar Drive. Though this tree has a number of small roots within 5 feet of the curb, no large roots were found.

Photograph 7. Tree 10 in front of 292 Gibraltar Drive.

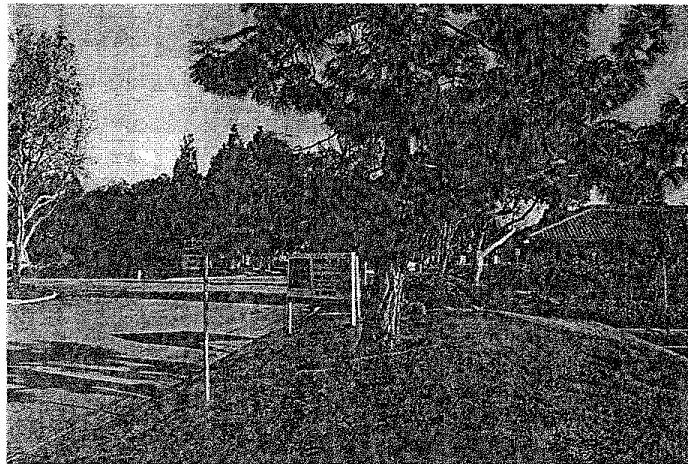
Tree 11, shown in Photograph 8, also was only found to have only small roots within 5 feet of the curb. This tree has a circling, girdling root system (Photograph 9). Circling roots represent a major defect in the root system of a tree. They are usually the result of a root-bound condition in a nursery container, which causes roots to grow in a circle around the outside of the root ball. Circling roots can stunt the tree because they restrict trunk diameter growth. They can also create tree stability problems because of lack of anchoring by primary roots. At present this tree appears healthy, probably because it has developed a secondary system of small adventitious root to replace the primary roots. However, it should be evaluated for tree hazard in the future and may be a candidate for removal if the root system is considered seriously compromised.

Photograph 8. Tree 11 in front of 292 Gibraltar Drive.

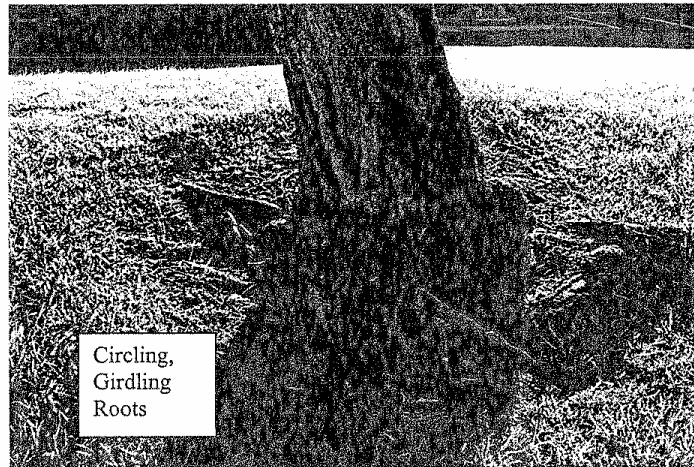
Photograph 9. Base of trunk of tree 11 showing circling, girdling roots.
